Manhole Inspection Summary

Manhole # S31CC_033MH

Location Address: **201 MARTIN LUTHER KING JR BLVD** Cross Street: **HOWARD ST**

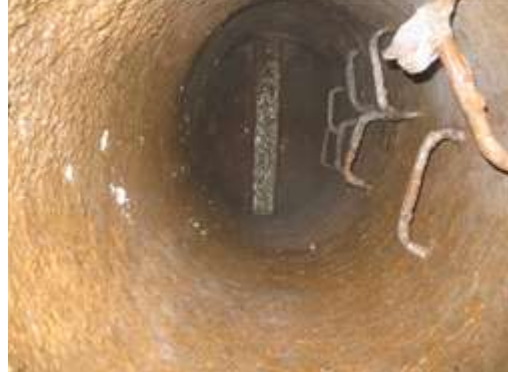
Top View

Steps Count: **8** Missing: **0** ☒ **Corroded**

Surcharge ☒ **Evidence Of Surcharge** Depth: **10** (ft.) ☐ Active Surcharge Present

Corroded steps. Evidence of surcharge - Bench debris.

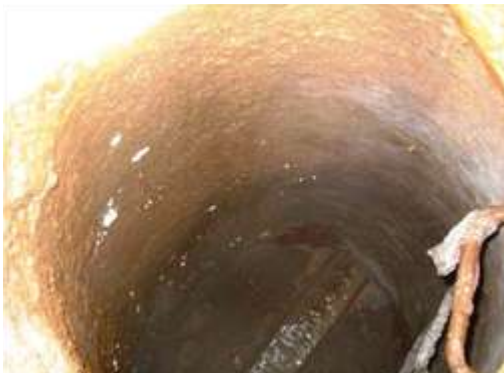
Defect

Chimney / Frame Adjustment ☒ Exists Material: **Unknown** ☐ Parged Height: **12** (in.)
Condition: ☐ Sound ☐ Cracked ☐ Root Intrusion ☒ **Loose Brick** ☒ **Deteriorated**
Infiltration: ☐ None ☒ **Joint** ☐ Cracks ☒ **Mortar** ☐ Roots ☒ **Wall**

Corbel Material: **Unknown** ☐ Parged Type: **Concentric/Eccentric**
Condition: ☒ Sound ☐ Cracked ☐ Root Intrusion ☐ Loose Brick ☐ Deteriorated
Infiltration: ☐ None ☐ Joint ☐ Cracks ☐ Mortar ☐ Roots ☒ **Wall**

Barrel Material: **Unknown** ☐ Parged
Shape: **Circular** Diameter: **42** (in.) Length: (in.)
Condition: ☒ Sound ☐ Cracked ☐ Root Intrusion ☐ Loose Brick ☐ Deteriorated
Infiltration: ☐ None ☐ Joint ☐ Cracks ☐ Mortar ☐ Roots ☒ **Wall**

Adjustment, Corbel and Barrel infiltration.

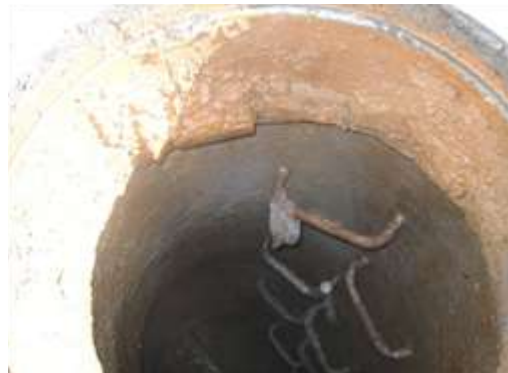
Defect

Frame Offset: **3** (in.) Condition: ☐ Sound ☐ Cracked ☒ **Leaks**

Frame leaks. Adjustment deterioration, loose brick and infiltration.

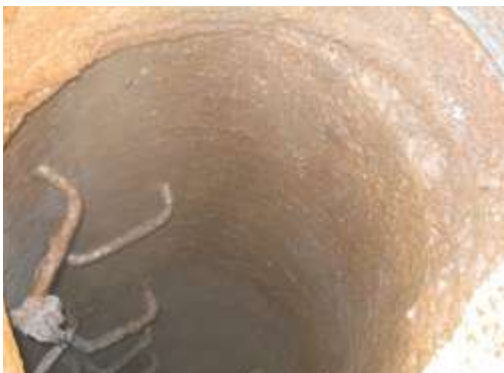
Defect

Frame leaks. Adjustment infiltration - other side.

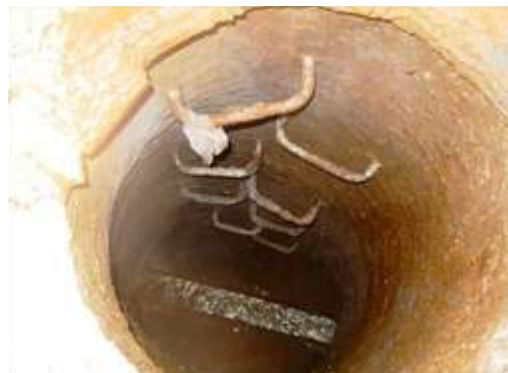
Defect

Frame leaks. Adjustment infiltration.

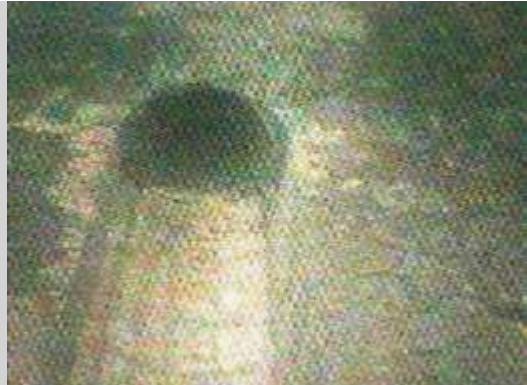
8 in. Circular Gravity Sewer Pipe Out @ 12 O'Clock

Infiltration: **Evidence** Pipe Seal Cond: **Unknown**

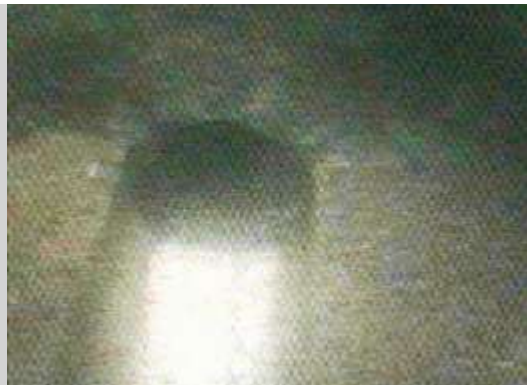
8 in. Circular Gravity Sewer Pipe In @ 6 O'Clock

Infiltration: **Evidence** Pipe Seal Cond: **Unknown**
